Manual vs. Automation

Clean Probes are Critical for a Successful High-Level Disinfection

A comparison between the cleanliness of manually-cleaned endocavity and surface ultrasound probes to those reprocessed with CS Medical Ethos® Automated Cleaner Disinfector

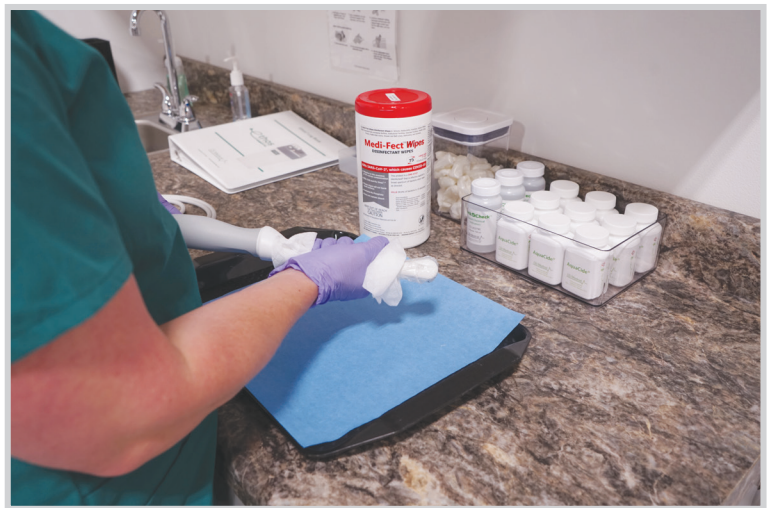
Manual point-of-care cleaning of an ultrasound transducer.

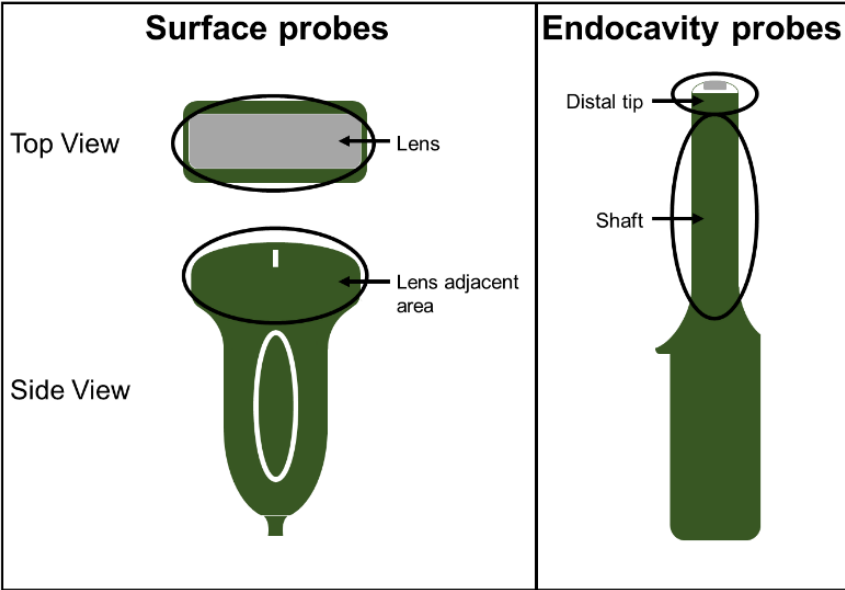
Figure 1. Surface probes were soiled on the lens and lens adjacent area, while endocavity probes were soiled on the distal tip and shaft as shown by the black circles.

Prior to cleaning, the surface probes were soiled on the lens and lens adjacent areas (Figure 1), while the endocavity probes were soiled on the distal tip and shaft areas. A model soil ⁽¹²⁾ comprised of 75% Edinburgh Soil/25% ultrasound gel (w/w) was applied directly onto each probe surface without the use of a protective sheath and allowed to dry. This soiling method provided the “worst-case scenario” cleaning challenge. The clinicians were provided with the same cleaning wipes used at their clinics and any other available supplies they requested during the cleaning process. Following cleaning by experienced clinicians, CS Medical staff carefully inspected each probe for remaining visible soil. The cleaned probes were then swabbed in their entirety to collect any remaining residue on the probes. The residue was assayed for protein as a soil marker based upon FDA guidance for reprocessing of reusable medical devices ⁽¹³⁾.

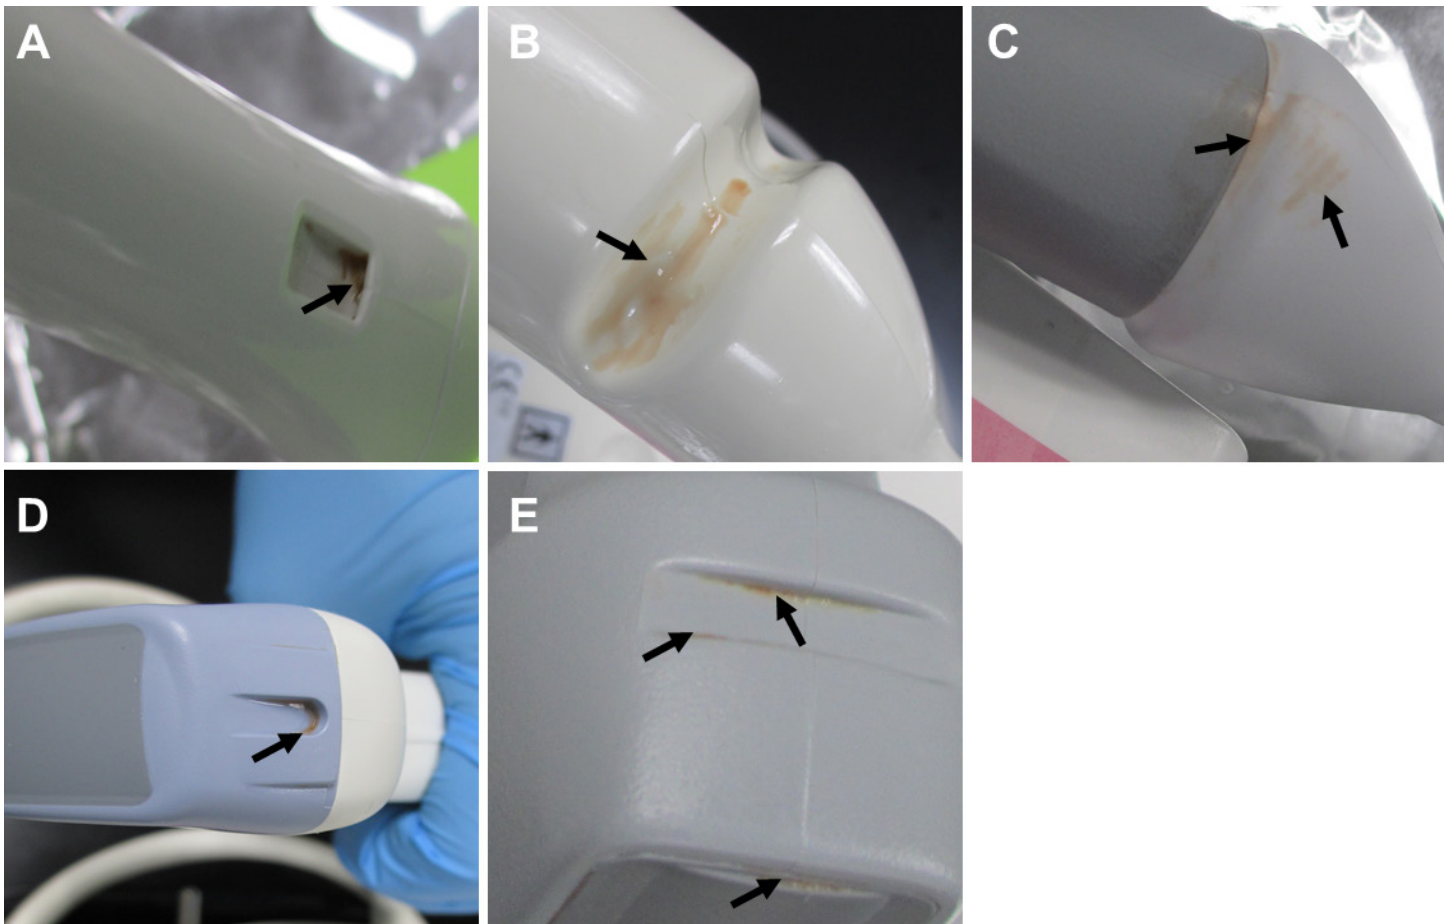
Figure 2. Visible soil was observed within indentations on multiple probe types. Black arrows designate remaining visible soil (red). The divot photographed in (A) proved difficult for all three clinicians to clean, while the areas in (B) and (C) only contained visible soil after cleaning by one clinician suggesting it may have been the result of human error. Divots on surface probes like those in (D) and (E) consistently contained visible soil following manual cleaning.

Examination of the manually cleaned probes revealed visible soil remaining on many of the probes. Residual soil was often observed within indentations on the probes that are used for accessories, though no accessories were used in this study (Figure 2). All of the experienced clinicians used supplemental techniques to clean difficult areas of the soiled probes including indentations. These supplemental techniques included using dry swabs or swabs dipped in water to remove soil, or wrapping a wipe around the swab before applying it to the soiled areas. However, even with the use of supplemental procedures, visible soil remained within indentations on many of the probes after manual cleaning suggesting these areas are difficult to clean using manual methods. Clinician 1 acknowledged the presence of remaining soil in a divot on one of the probes and stated that in the clinic the probe would be run through a disinfection cycle and visually inspected again. If there was remaining soil on the probe following disinfection, the probe would be cleaned and disinfected again, until no visible soil remained. The soil remaining in this divot following cleaning by clinician 1 was excluded from the protein analysis because the tools required to complete the cleaning to the clinician's satisfaction (i.e. a method for completing a disinfection cycle) were not available.

Our study suggests there are two potential downfalls of manual cleaning methods: they can be highly operator dependent and divots in probes can be difficult to clean. The clinicians recruited for this study were experienced, with one clinician having 21 years of experience. However, differences in training or human error could result in the variability in manual cleaning between clinicians we observed. Recent guidance published by the Society of Diagnostic Medical Sonography (SDMS) recommends that cleaning of ultrasound transducers should remove all visible gel, soil, and bioburden from probes including from indentations ⁽¹⁴⁾. In this study, manual cleaning with wipes resulted in visible soil on at least one probe cleaned by each of the three clinicians; most of which was found within probe divots. These observations suggest that meeting the recommended cleaning standards using manual methods may be more difficult than is appreciated.

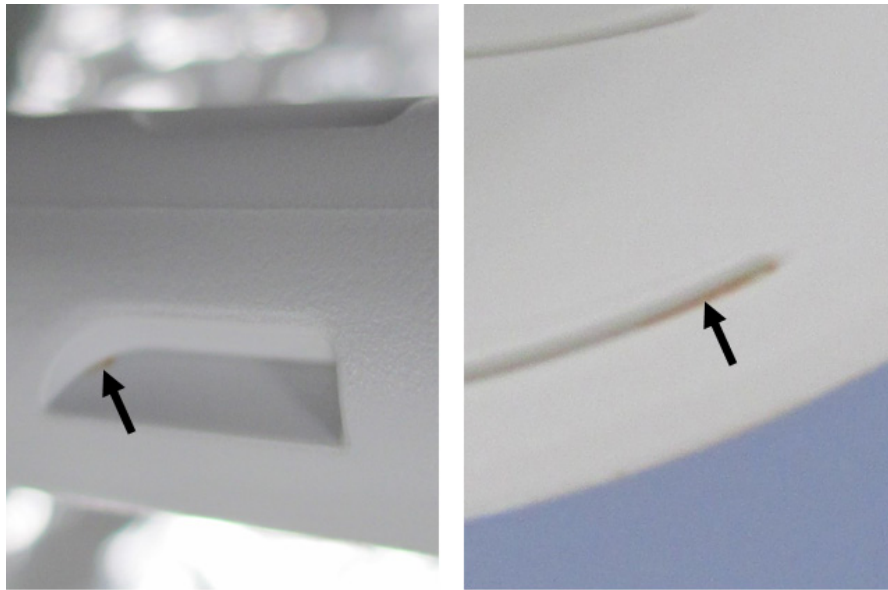
Figure 3. Small amounts of residual soil on probes could be difficult to detect with the unaided eye.

Visible soil remaining on the probes following cleaning was not acknowledged for any other probe or by the other clinicians. The level of soil remaining on probes varied considerably, but was often a visibly small amount. In some cases, the amount of visible remaining soil on the probe combined with its location (i.e. in a crevice/crack) made it difficult to see with the unaided eye (Figure 3). As a clinician's day gets busy cleaning gets rushed so they can turn the room around for another patient, which can also cause improper cleaning.

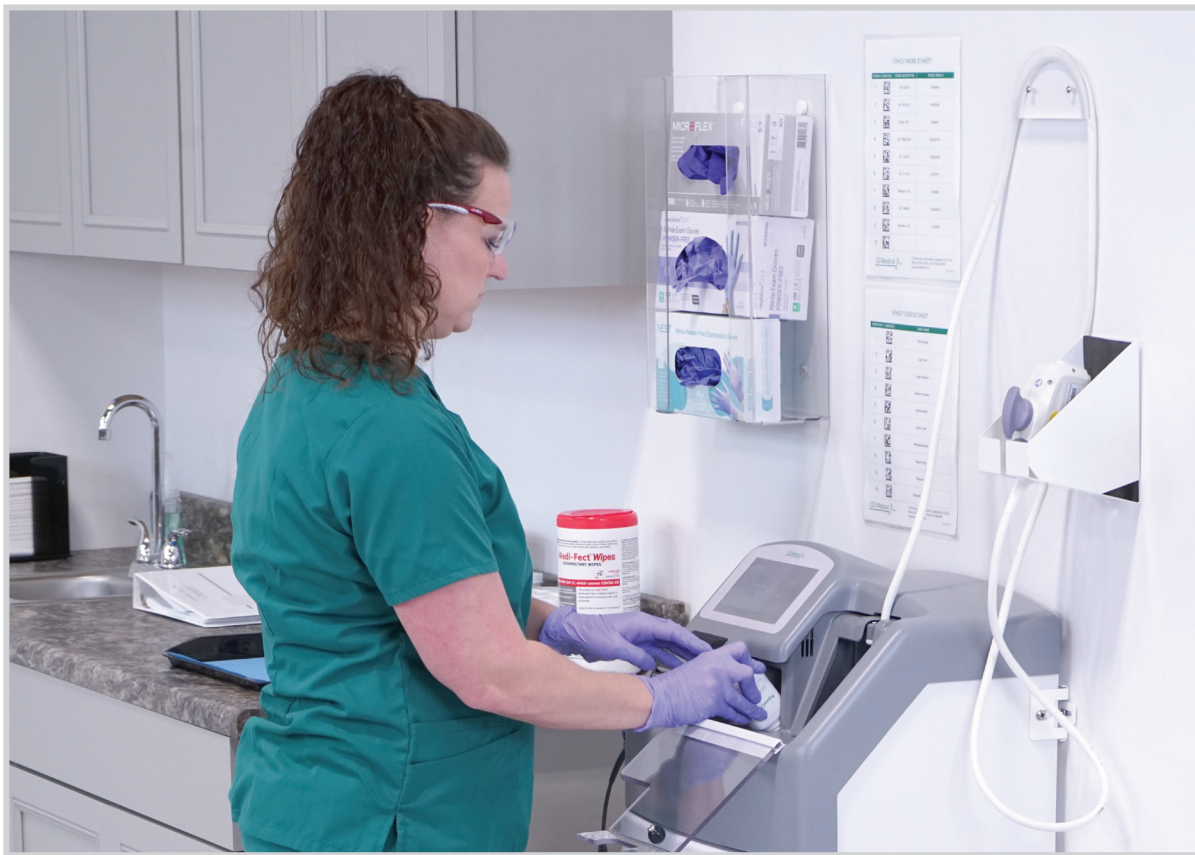
After probe is placed in Ethos, AquaCide cleaner disinfectant is added prior to cleaning and HLD cycles.
